Fatigue prevention retrofit for connections of main girder to transverse beam or sway bracing in steel bridges

Luiza Hiroko Ichinose^{*,a}, Masahiro Koyama^b, Masahiro Sakano^c

ABSTRACT

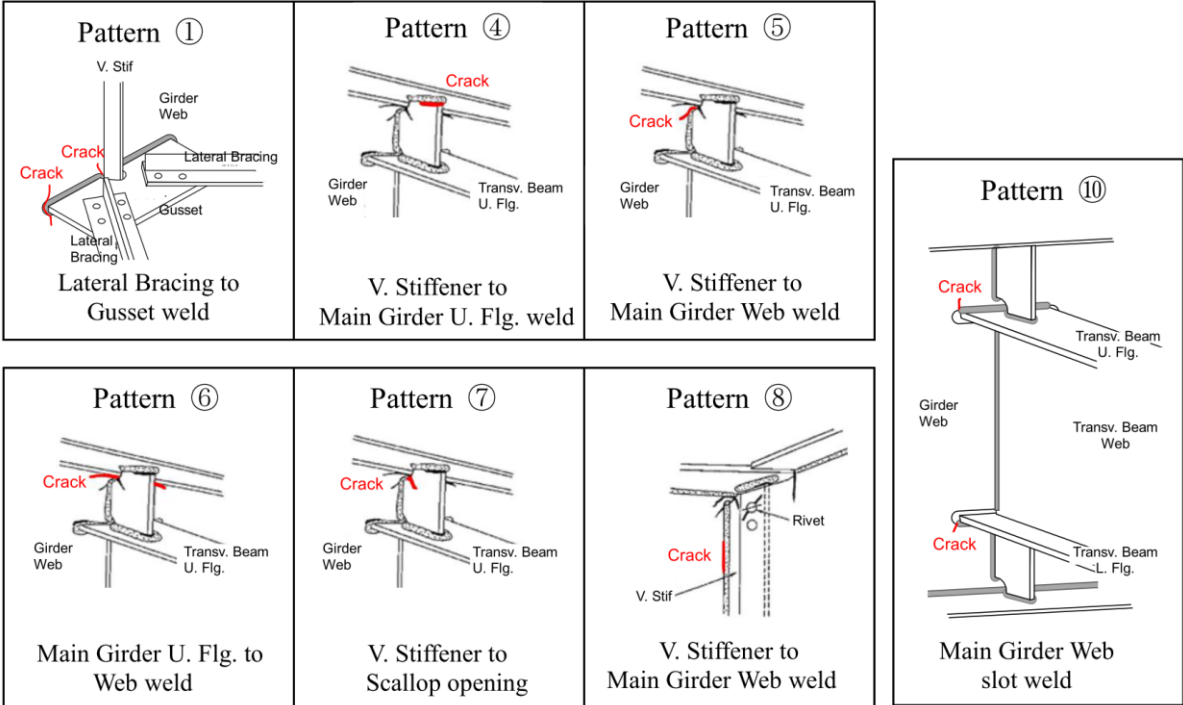
Fig. 2. Damage patterns found in the selected bridge

Visual inspections carried out in 2012 revealed that more than 4000 locations presented cracks in their paint coating [6]. As fatigue cracks are often found underneath cracks in the coating, these cracks are considered to be potential fatigue cracks. Crack patterns found in the bridge are presented in *Fig. 2*, and their respective numbers are shown in *Table 1*. Among the various patterns of coating cracks found during the visual inspections, the present paper will focus on crack patterns ④ and ⑩. The former, presenting the highest occurrence among the crack patterns found in the bridge, is also one of the crack patterns with the highest occurrence in Japanese bridges. The latter is a crack pattern that may propagate into the main girder web and grow to an extent that can compromise the structural safety of the bridge, being, therefore, considered to be one of the most critical damage patterns found in Japanese bridges. [4, 7, 8]

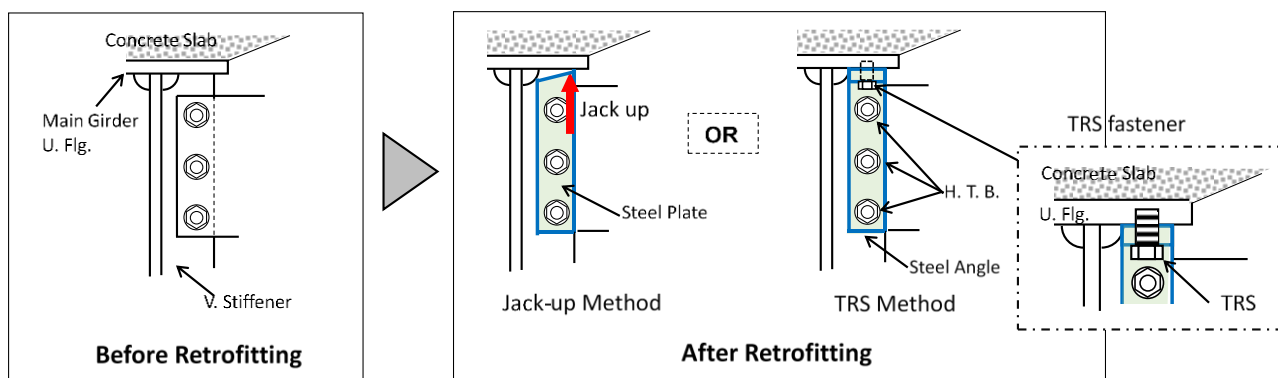
Fig. 4. Retrofit for damage pattern ④

Two types of retrofit were applied for damage pattern ④ at connection between vertical stiffener and sway bracing connection, as shown in *Fig.4.*

The first method reinforced the upper part of the vertical stiffener by attaching steel plates at both sides of the vertical stiffener using high tension bolts, which were fastened after jacking-up the reinforcing plates against the main girder upper flange. A screw type jig was applied to jack-up the reinforcing plates so that the part of the load transmitted to the vertical stiffener is transferred to the reinforcing plates, relieving the stress concentration at the upper end region of the vertical stiffener [2, 7].

The second method applied steel angles at both sides of the upper part of the vertical stiffeners and fastened them to the main girder upper flange by means of Thread Rolling Screw (TRS) [7], which secured fastening to the upper flange, from its bottom side, without perforating the flange material into the concrete. The steel angle is fastened to the lower surface of the main girder upper flange so that the load transmitted to the vertical stiffener is relieved by transferring part of it to the steel angles [7.8]. The TRS method was also applied to the web gap plate upper end at the transverse beam connection, as shown in *Fig. 7.*

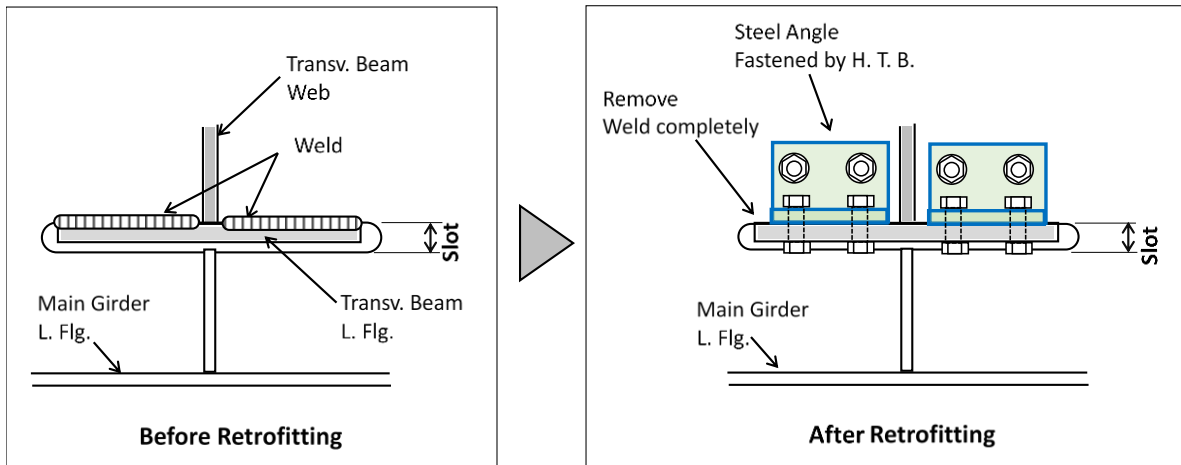
Fig. 5. Retrofit for damage pattern ⑩

At the location with damage pattern ⑩, which occurs at the main girder web slot through which the transverse beam flange is inserted, the weld connecting the transverse beam to the main girder web was completely removed and replaced by steel angles having equivalent resistance area, as shown

in Fig. 5 and 7 [4]. In this retrofit method, the weld bead along the slot in the girder web, considered to be one of the causes of stress concentration, is removed relieving the stresses around the slot edge area.

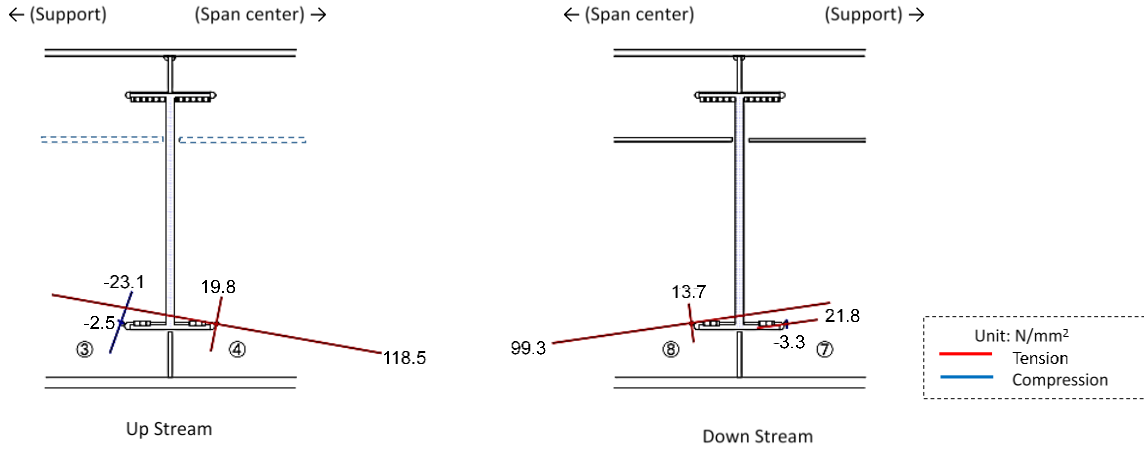
Fig. 10. Principal stresses at main girder web slot

Fig.10 shows an example of the stress measurement results. The figure shows the maximum principal stress for the girder web at the slot edge area in the vicinity of the weld connecting the girder web to the transverse beam lower flange. It was observed that, compared to the stresses occurring at the support side, higher tensile stresses occurred at the span centre side, tendency which were already confirmed in former laboratory tests [3].

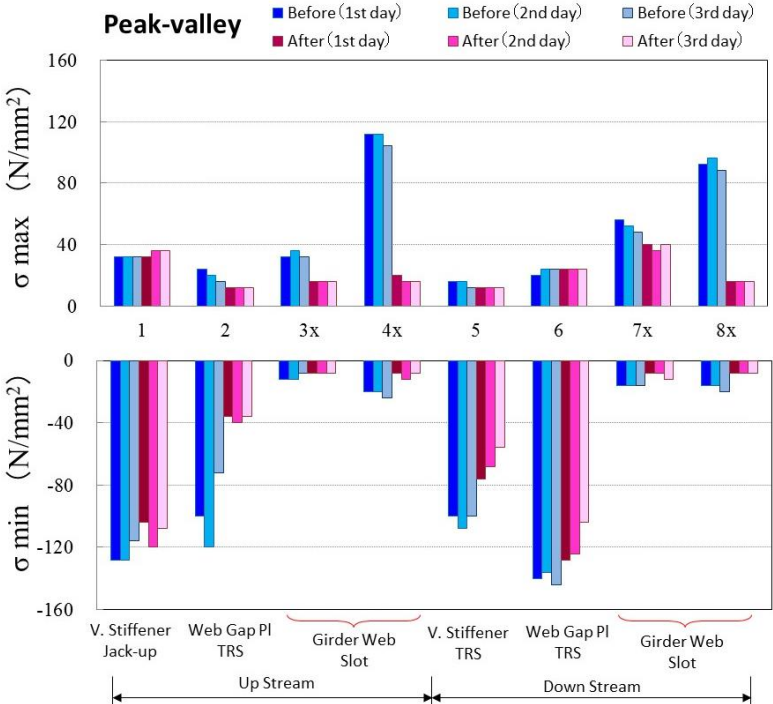
Fig. 11. Maximum and minimum stress before and after retrofitting (Peak-valley method)

Maximum and minimum values of stress distribution obtained according to the peak-valley method is presented in Fig. 11. Tensile stresses at the slot edge in the main girder web (gauge no. 4x and 8x) decreased considerably after the execution of the retrofits, although the decrease was not so conspicuous at the compression side. The figure also shows that, the compression stresses that were predominant at the vertical stiffeners and web gap plate upper end, decreased to a certain extent, whereas the tensile stresses did not present any considerable changes.

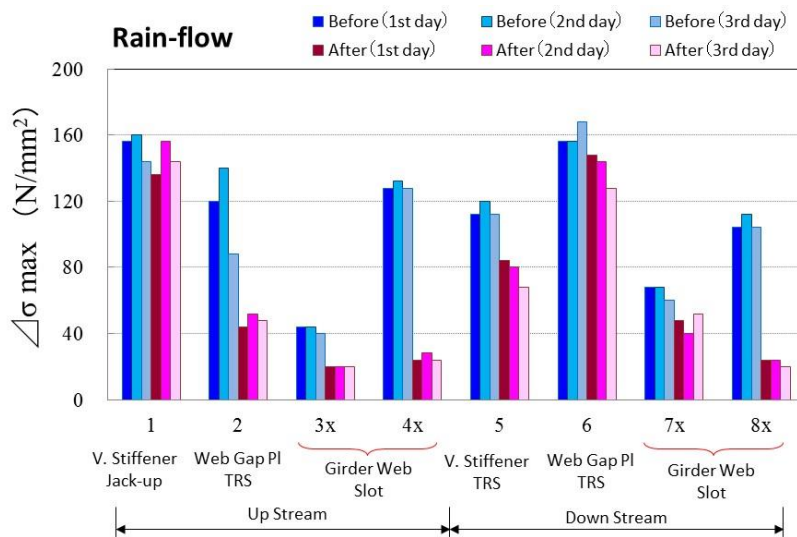
Fig. 12. Maximum stress range before and after retrofitting (Rain-flow method)

As for the stress range, the maximum stress range values did not change considerably (98% of the value before retrofitting) for the vertical stiffener upper end retrofitted by the jack-up method (from 160MPa to 56MPa), however for the location retrofitted by TRS method, the stresses after retrofitting reduced by 30% (from 120MPa to 4MPa), as shown in *Fig. 12*.

For web gap plate, the TRS method presented a drastic reduction of 35% (from 140MPa to 52MPa) of the stress range at the up-stream side and a reduction to 88% (from 168MPa to 148MPa) of the stress range value before the retrofitting was observed at the down-stream side.

The stress range around the slot edge locations, where high stress concentration was observed at the span centre side, decreased to 1/5 of the values before the retrofitting (from 132MPa to 28MPa and from 12MPa to 4MPa).

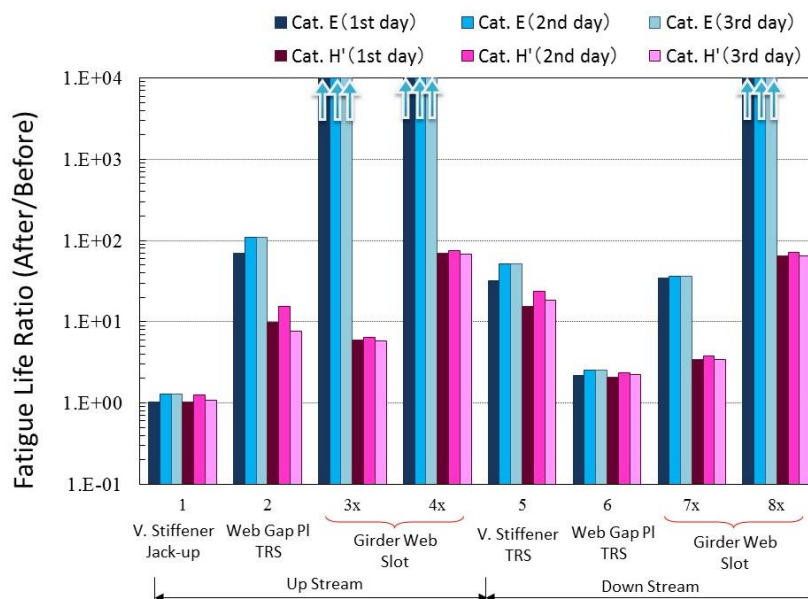
Fig. 13. Fatigue life ratio (after/before retrofitting)

Fatigue life for each location was evaluated for two cases, one, as category E according to the design recommendations of the Japanese Society of Steel Construction [9], which considers the hot spot stress influences, and the other, as category H', whose accumulated damage is similar to that of a modified Miner's rule based curve. The results are presented as fatigue life ratio (fatigue life ratio = fatigue life after retrofitting / fatigue life before retrofitting) in *Fig. 13*.

At the vertical stiffener upper end, the fatigue life for the jack-up method retrofit presented values that were 1.1 times of that of before retrofitting for both categories E and H'. However, the TRS method retrofit presented values that were 41 times of that of before retrofitting for category E and 19 times, for category H', improving enormously.

At the web gap plate upper end, the TRS method improved the fatigue life of the detail, when considered as category E, by 2 to 78 times the fatigue life before the execution of the retrofitting works and by 2 to 11 times, when considered as category H'.

For the girder web slot detail, the fatigue life was extended to almost infinity, when considered as category E. Even when considered as category H', the fatigue life of the detail increased by 70 times the value of before retrofitting, improving remarkably.

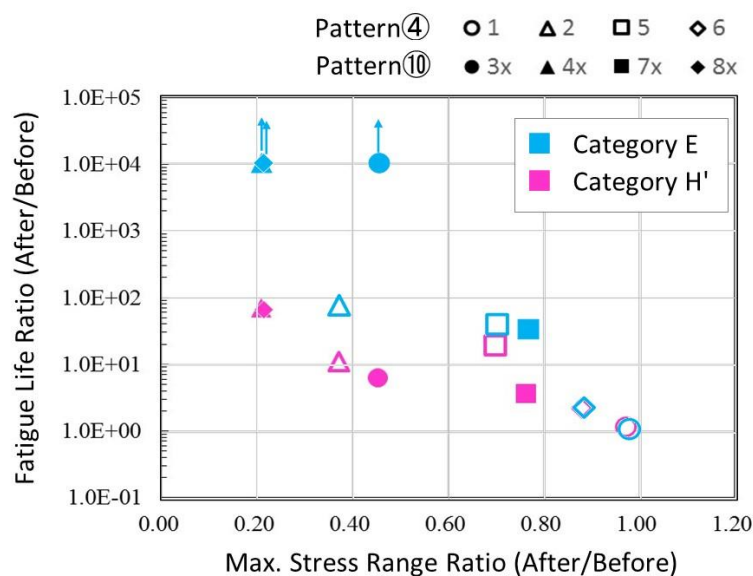
Fig. 14. Maximum stress range ratio and fatigue life ratio (after/before retrofitting)

The relationship between maximum stress range ratio and fatigue life ratio before and after retrofitting is shown in Fig. 14. In the figure, it can be observed that independent of the damage pattern and retrofit method, the fatigue life improved with the decrease of the maximum stress range.

It was clear from the figure that, in case the maximum stress range ratio is below 80%, that is, the reduction ratio is over 20%, the fatigue life improves by tens of times the original fatigue live, when evaluated as category E (plotted in blue), and by a few times, when evaluated as category H' (plotted in magenta).
