Fatigue strength and improvement effect of the center stay rod

Honshu-Shikoku Bridge Expressway, Kobe-shi, Hyogo, Japan

ABSTRACT: Center stay is installed to control a relative displacement between a girder and a cable, to restrict the inclination of short suspenders around the center of a span, and to prevent bending fatigue of the suspender. A center stay was designed so that the rod section breaks with 60% (equivalent of an earthquake whose return period is 25 years) of tension force during an earthquake. However, two rods under force lower than the designed tension broke at a mounting screw section, not at the section with the minimum cross sectional area of the rod, which is the assumed failure point. This paper discusses the detailed survey of a fracture surface observation to confirm damage factors, estimation of the level of fatigue damage by measuring a stress frequency on a real bridge, a method to improve fatigue durability, and the result of a fatigue test of improved rod with which improved fatigue durability is expected.

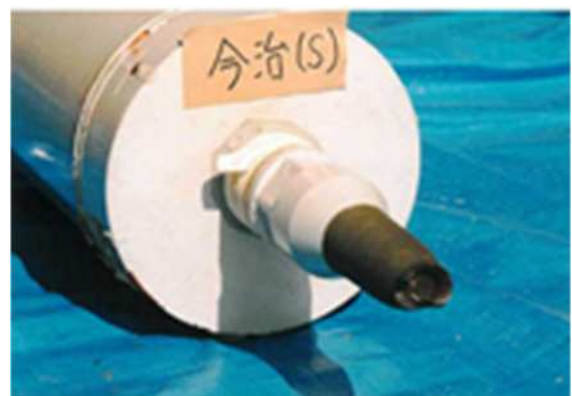
Photo.3 Breakage of the center stay rod caused by the Geiyo earthquake in 2001

The center stay is positioned in the center of the main span. It consists of stay band, a stay rod (hereinafter called “rod”), and anchorages as shown in Fig.3 and Photo.2. The total of four center stays are installed on the bridge, two for the up-bound lane side and two for the down-bound lane side. The rod was designed to be broken at the section with the minimum cross sectional area in the center during a large-scale earthquake. These rods were actually broken almost as designed load when the Geiyo earthquake (M 6.7) occurred in March 24, 2001 as shown in Photo3.¹⁾

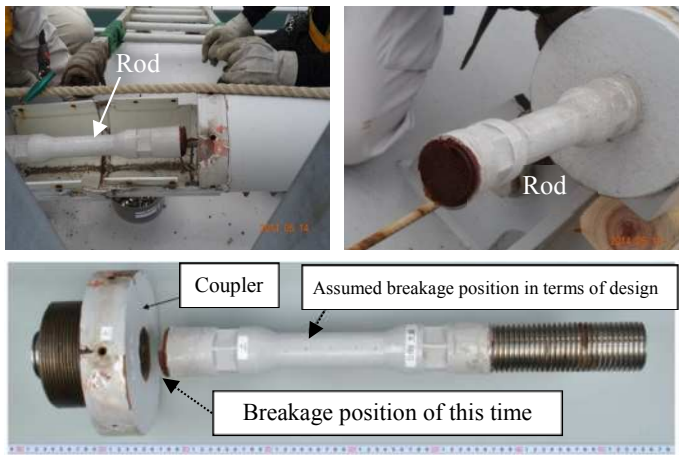
Photo.4 Condition of break in the rod

The position of the breakage is the thread root at the first screw thread where the rod is engaged with the socket coupler on the rope side. (Photo.4)

The existing rods were replaced because they were broken when the Geiyo earthquake occurred in March 2001. It is relatively new rod as it is about 13 years old. The assumed position of the breakage is the minimum cross sectional area in the center of the rod as shown in Fig. 3, which is a different position of the broken rods this time.

From the above mentioned results, it was confirmed that the assumed damage was led to following reason the assumed damage. A crack by repetitive stress gradually developed starting from the thread root so that the decreased cross section cannot bear with a pulling force. As a result, the breakage become large gradually.

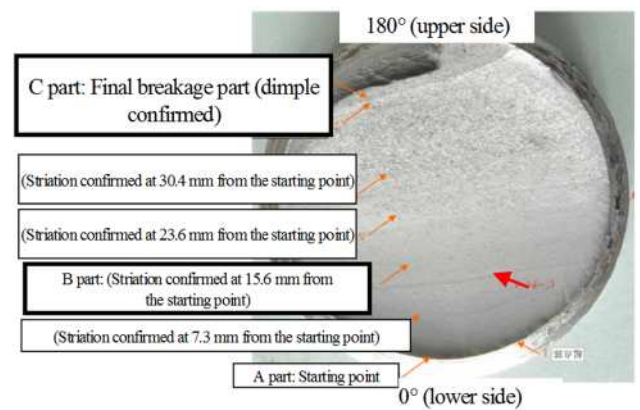
(a) Result of macro-observation

The result of the macro-observation of the fracture after descaling is shown in Fig.4(a).

Distinctive beachmark was found on the fatigue fracture of the two broken rods; therefore, it is assumed that fracture developed due to a repetitive stress.

The final breakage part is identified on the top of any section. When the transmission direction was assumed from the pattern of the beachmark, the starting point of the breakage was believed to be on the lower side.

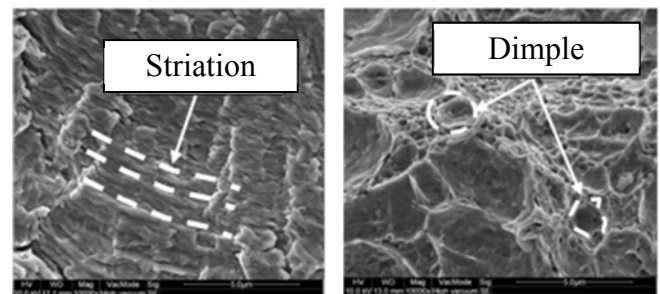
(b) SEM image of B part

The trace of occurrence of crack caused by defects and the corrosion was not found from the condition of the fracture in the neighborhood of the starting point. Distinctive striation (a striped pattern) was identified on the fatigue fracture as shown in Fig. 4 (b). And, on the top side that is assumed to be the final breakage part, a significant dimple (a hallow pattern) was identified on the ductile fracture as shown in Fig. 4 (c).

According to the results of the macro-observation and the cross-sectional observation with micro-observation by SEM, no defects including corrosion and fine cracks were identified.

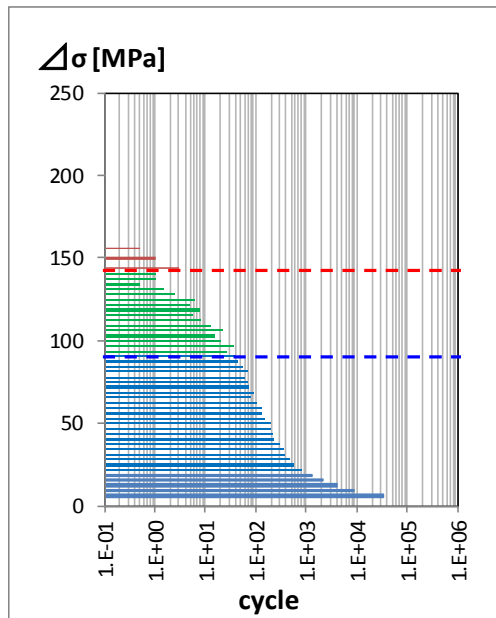
(a) Up-bound lane
(end point side)
Unbroken rod

Fig.6 shows the result of the stress frequency analysis of the measurement result which was converted from strain gauge of 0° to cross section area of thread root by FEM result as described next section. The strength ranges of 0° was larger than 120° , 240° . In addition, the strength ranges of down bound lane was larger than up bound lane.

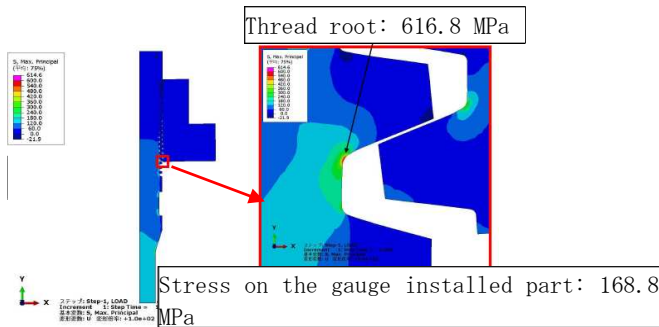
Fig.8 Result of the analysis (figure of the maximum principal stress contour)

Fig.8 shows the maximum principal stress contour when tensile load to the axis direction was applied. The stress concentration was identified from the thread root R located in the first row from the engaged part that is assumed as the starting point of the fatigue crack.

Table 1 shows the relation between radius and stress of the thread root R. In the result of the analysis, reduction of the stress concentration by the increasing the thread root R was confirmed. As a result, the structure of the thread root R of 0.7mm that was decided the structure of rod for the fatigue measures.

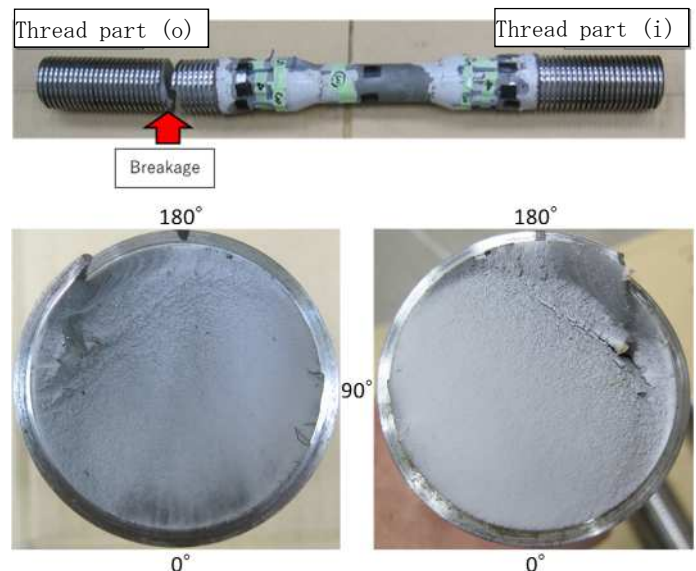
Photo.5 Existing rod after the test

Typical results for each test piece are discussed in this section. Photo.5 shows the existing rod after the test. With the existing rod, breakage occurred at the thread part after load was applied 520,000 cycles. The position of breakage is the thread root of the first screw thread engaged with the anchoring body. And, by the breakage surface, to breakage is assumed an arc-like crack occurred in between 0 degree and 90

degrees. Therefore, fatigue breakage occurred at the actual bridge is believed to be reproduced.

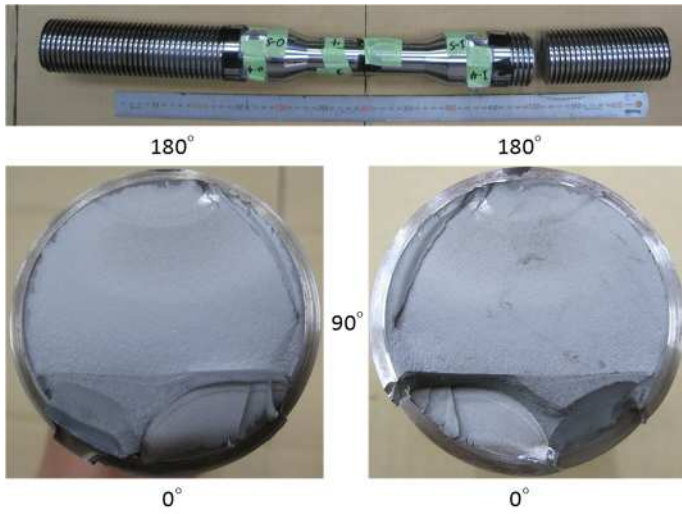
Photo.6 New rod (R0.3) after the test

Photo.6 shows the new rod (R0.3) after the test. With the new rod (R0.3), breakage occurred at threaded part after load was applied 1,620,000 cycles. The position of breakage is the thread root of the first screw thread engaged with the anchoring body, which is similar to that of the existing rod. And, by the breakage surface, to breakage is assumed an arc-like crack occurred in about 180 degrees.

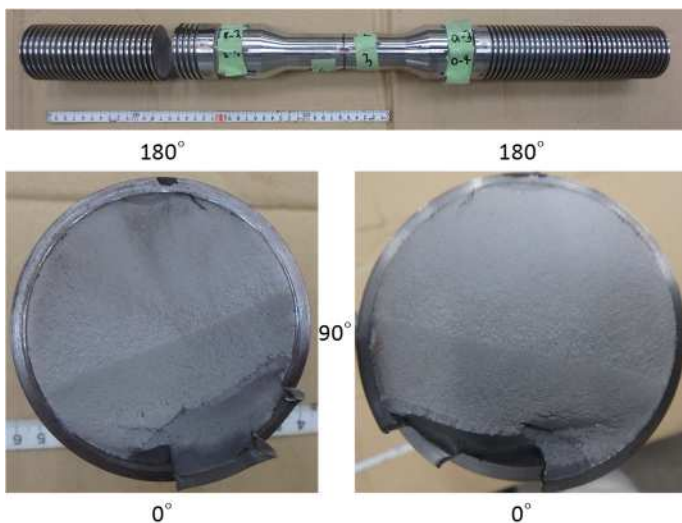
Photo.7 New rod (R0.7) after the test

Photo.7 shows the new rod (R0.7) after the test. With the new rod (R0.7), crack did not occur by the load range $\Delta P = 130$ kN. Therefore, the load range $\Delta P = 260$ kN ($P = 20-280$ kN) was set. In the result, breakage occurred at threaded part after load was applied 410,000 cycles. The position of breakage is the thread root of the first screw thread engaged with the anchoring body, which is similar to the other rods. And, by the breakage surface, to breakage is assumed an arc-like crack occurred in about 180 degrees.

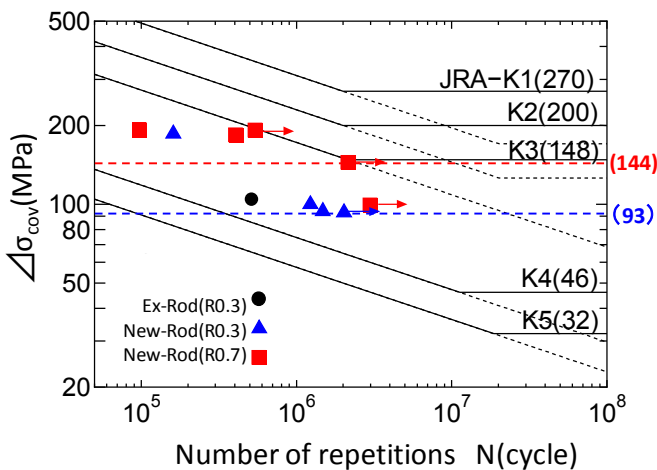
Fig.13 Summary of the result of fatigue tests

From Fig. 13, the existing rod has a shorter fatigue life than the new rod (R0.3). The existing rod is assumed had damage in actual bridge. And, in new rods (R0.3), it is assumed that there is a fatigue limit in 93MPa. In new rods (R0.7), it is assumed that there is a fatigue limit in 144MPa. Therefore, fatigue limit was increased to 1.5times by the changing the fatigue

limit from 93MPa to 144MPa. Therefore, the fatigue strength is improved by changing the thread root R from 0.3mm to 0.7mm.

Meanwhile, it was confirmed that the fatigue life of one of the new rod (R0.3) and one of the new rod (R0.7) are reversed. According to the hearing investigation of the manufacturer, about ±0.1 mm of
