## Development of retrofitting method against fatigue cracks in orthotropic steel deck stiffened by trough ribs

In this paper, development of a retrofitting method using Thread Rolling Screw from the underside of the deck, fatigue test results and application test in an in-service bridge are described.

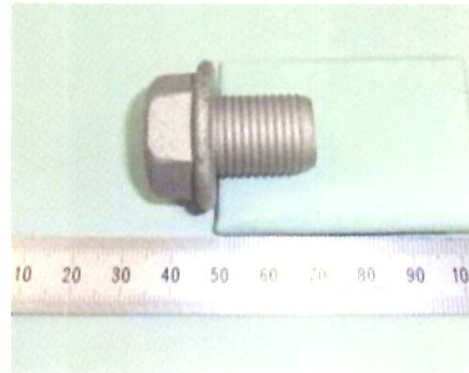
Figure 5. TRS

As bearing joint, tap bolt (TB) and Thread Rolling Screw (TRS) are selected. In a method using TB, the bolt is screwed after steel plate is perforated and tapped. On the other hand, in a method using Thread Rolling Screw (TRS), the bolt is screwed forming female threads on perforated steel plate [12]~[14]. Also, as a bench mark to evaluate these methods, friction joint with torque shear bolt (HTB) is tested as well. Connection of splicing plate and trough rib is one side bolt (MUTF20) for all types. Figure 4 shows details of each retrofitting method, and Figure 5 shows TRS.

⑤ From the view point of workability, TB and TRS can be applied from the underside. Especially for TRS, shaving process can be omitted compared with TB. TRS has higher workability and therefore has advantage over TB.

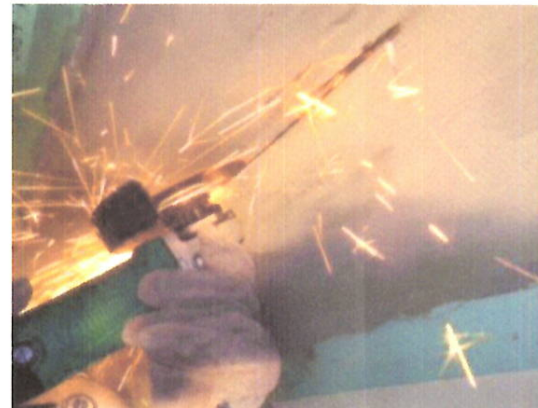
Figure 7. Cutting bead

- (2) Cut bead in trough-deck weld (Figure 7)
- (3) Attach splicing plate temporarily using magnet tool (Figure 8)
- (4) Drill hole for TRS $\phi$ 12 bolt in deck (drilling diameter is  $\phi$ 11.5, Figure 8)
- (5) Attach splicing plate temporarily using TRS  $\phi$  12
- (6) Drill bolt hole in trough rib for MUTF20
- (7) Tighten temporarily two MUTF20 bolts near the center in trough rib side
- (8) Drill bolt hole in deck for TRS $\phi$ 16 (drilling diameter is  $\phi$ 15.5)
- (9) Tighten TRS $\phi$ 16 in deck (Figure 9)
- (10) Tighten temporarily all MUTF20 bolts in trough rib side
- (11) Tighten fully all MUTF20 bolts in trough rib
- (12) Rustproof with sealing and painting

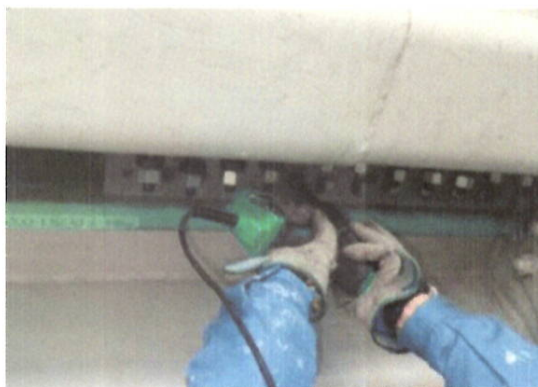
Figure 9. Tightening TRS $\phi$ 16

(8)-(9) is executed for each bolt from the end of splicing plate toward center. After all TRS $\phi$ 16 have been tightened, (10)-(12) are executed. Figure 10 shows splicing plate after installation, and Figure 11 shows details of each retrofitting method.

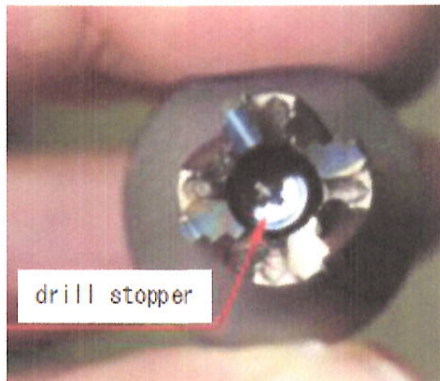
Figure 12. Drilling blade for deck side

- Drilling blade with drill stopper: control drilling depth not to damage pavement when drilling in deck side(Figure 12).
- Center pin with magnet : prevent drilled core from falling inside of trough rib(Figure 13).

- Efficient application angle of cutting machine for bead cut, and how to recognize appropriate cut depth.
- Selection of proper cutting tools for general weld line and one close to cross rib for bead cut.
- Confirm that the protrusion of cutter above deck surface is less than 1mm by developed drill stopper.
- Confirm that splicing plate does not move by the temporarily fixation by magnet when drilling.
- Confirm that TRS can be tightened vertically upward by the developed jig.
