Fatigue prevention retrofit for connections of main girder to transverse beam or sway bracing in steel bridges

Luiza Hiroko Ichinose^{*,a}, Masahiro Koyama^b, Masahiro Sakano^c

ABSTRACT

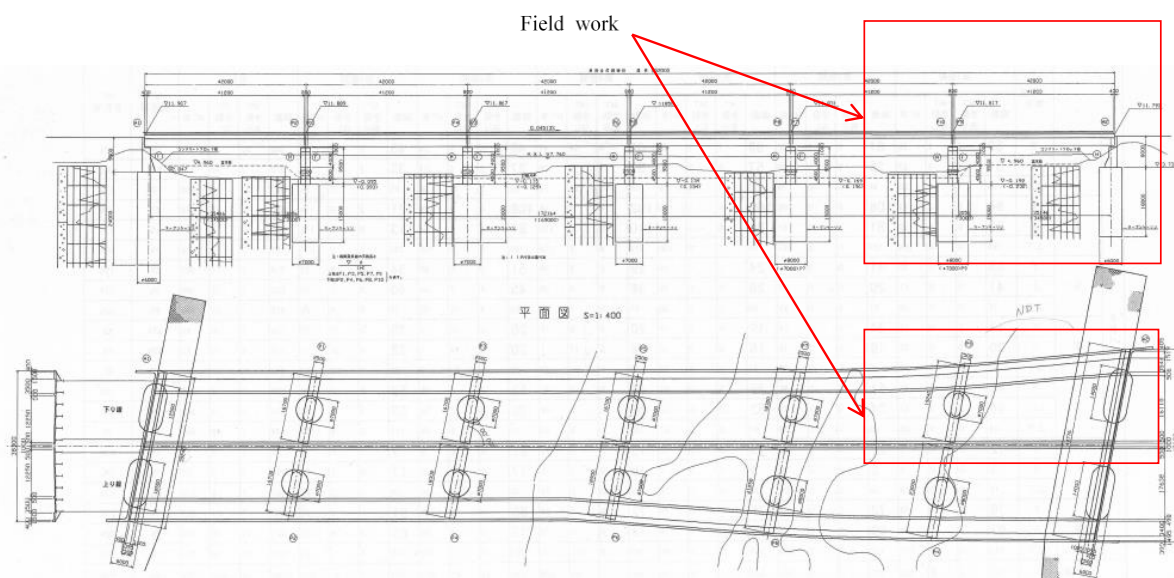
Fig. 1. Bridge selected for stress measurement

The bridge selected for field work was completed in 1972 and its plan view is presented in Fig. 1. As it is shown in the figure, the bridge is composed by 6 consecutive spans of simply supported composite steel girders, each of them having a span length of 41.2m and an average bridge width of 18.8m, accommodating a road with 6 traffic lanes, supported by 6 main girders. The bridge is located in one of the busiest routes in Japan and, according to a census carried out in 2010, the

traffic volume that crosses the bridge is about 120,000 vehicles per day, 21.2% of which are considered to be heavy loaded vehicles. Due to its easy accessibility the 6th span, shown in *Fig. 1*, was chosen for the execution of retrofit works and stress measurements.

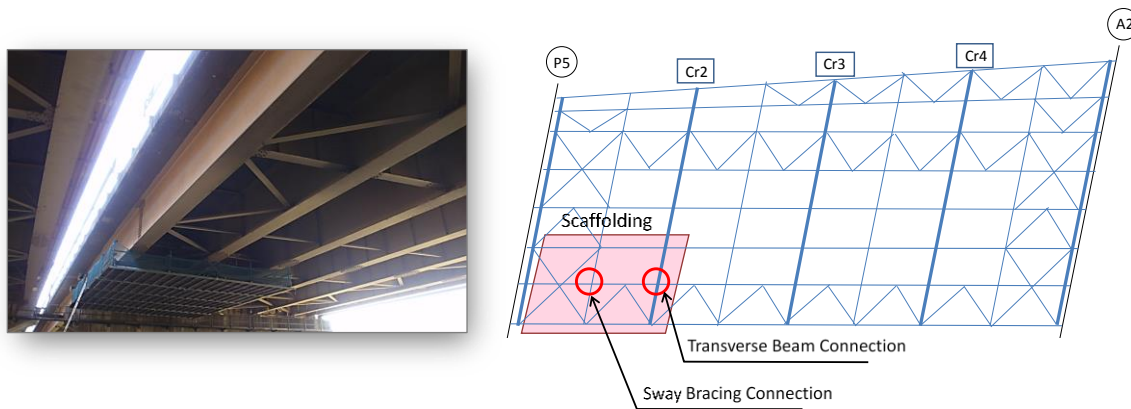
Fig. 3. Location of the retrofitting works

Retrofits were executed at the locations shown in *Fig. 3.* for the damage patterns ④ and ⑩, according to the proposed methods.

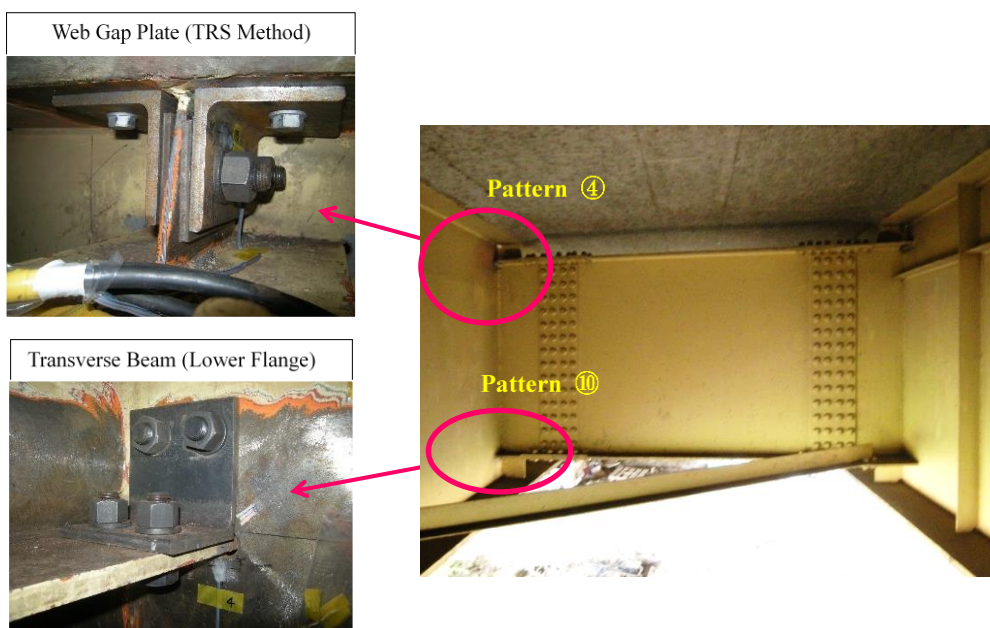
Fig. 7. Transverse beam connections retrofit

in Fig. 5 and 7 [4]. In this retrofit method, the weld bead along the slot in the girder web, considered to be one of the causes of stress concentration, is removed relieving the stresses around the slot edge area.

At the location with damage pattern ⑩, which occurs at the main girder web slot through which the transverse beam flange is inserted, the weld connecting the transverse beam to the main girder web was completely removed and replaced by steel angles having equivalent resistance area, as shown

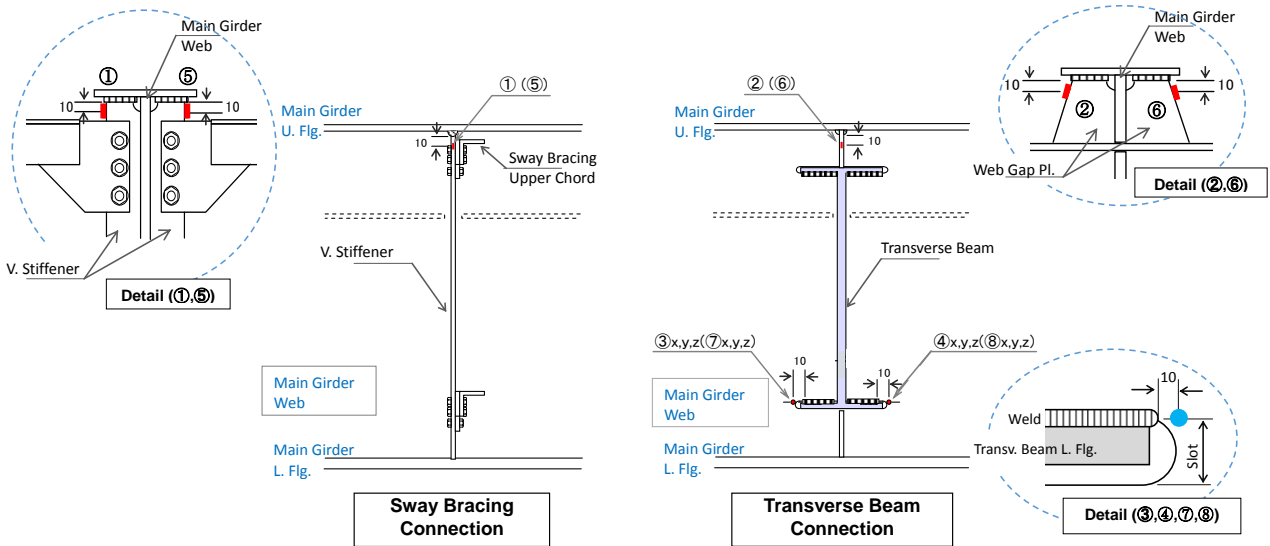
Fig. 8. Strain gauge location – Before retrofitting

Fig. 8 shows the strain gauge locations before the execution of the retrofits. The measurement points were selected focusing at stress concentration areas of the vertical stiffener and web gap plate upper end welds, as well as, the region around the slot edge in the main girder web.

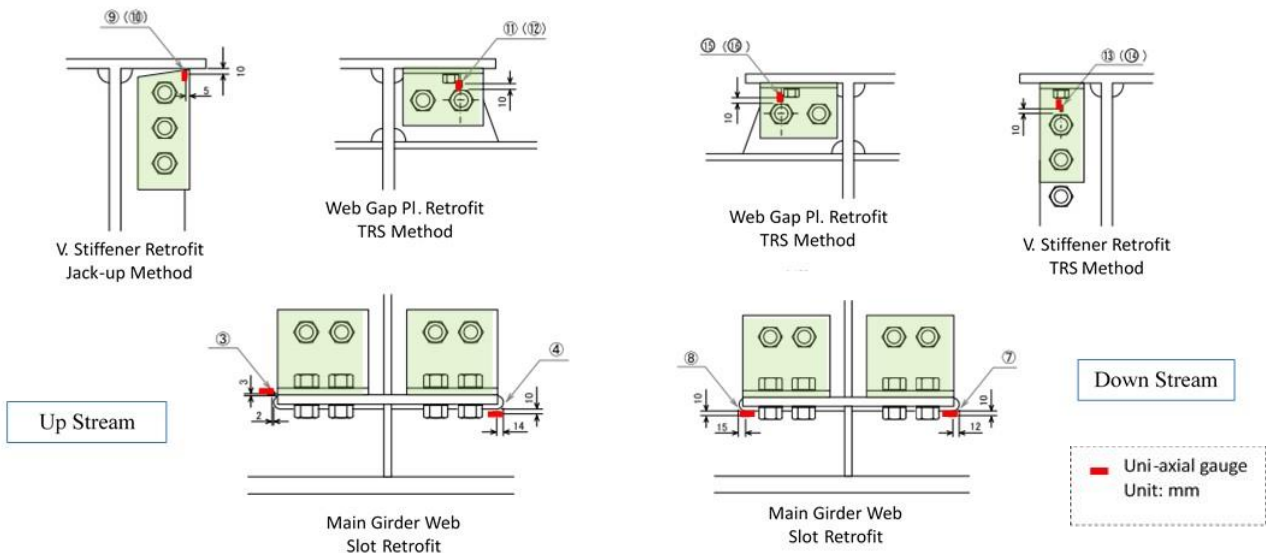
Fig. 9. Strain gauge location – After retrofitting

The strain gauges for the measurements carried out after the execution of the retrofits are shown in Fig. 9. Additional gauges were placed on the reinforcing plates and steel angles so as to monitor the stress redistribution after the retrofitting works.

The stress range around the slot edge locations, where high stress concentration was observed at the span centre side, decreased to 1/5 of the values before the retrofitting (from 132MPa to 28MPa and from 12MPa to 4MPa).
