Fatigue strength and improvement effect of the center stay rod

Honshu-Shikoku Bridge Expressway, Kobe-shi, Hyogo, Japan

ABSTRACT: Center stay is installed to control a relative displacement between a girder and a cable, to restrict the inclination of short suspenders around the center of a span, and to prevent bending fatigue of the suspender. A center stay was designed so that the rod section breaks with 60% (equivalent of an earthquake whose return period is 25 years) of tension force during an earthquake. However, two rods under force lower than the designed tension broke at a mounting screw section, not at the section with the minimum cross sectional area of the rod, which is the assumed failure point. This paper discusses the detailed survey of a fracture surface observation to confirm damage factors, estimation of the level of fatigue damage by measuring a stress frequency on a real bridge, a method to improve fatigue durability, and the result of a fatigue test of improved rod with which improved fatigue durability is expected.

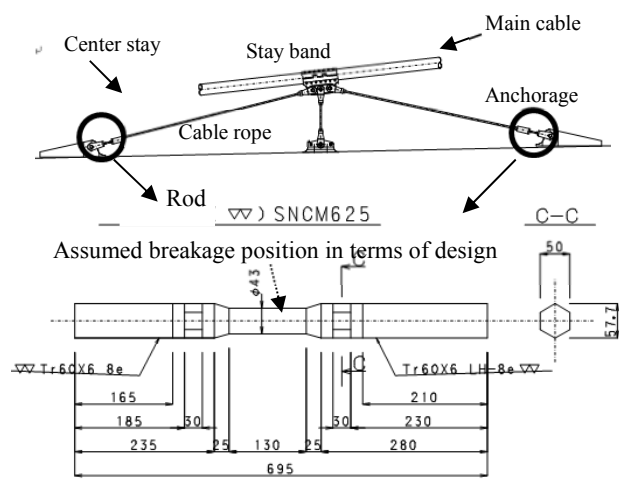
Fig.3 Outline of center stay

The center stay is positioned in the center of the main span. It consists of stay band, a stay rod (hereinafter called “rod”), and anchorages as shown in Fig.3 and Photo.2. The total of four center stays are installed on the bridge, two for the up-bound lane side and two for the down-bound lane side. The rod was designed to be broken at the section with the minimum cross sectional area in the center during a large-scale earthquake. These rods were actually broken almost as designed load when the Geiyo earthquake (M 6.7) occurred in March 24, 2001 as shown in Photo3.¹⁾

The existing rods were replaced because they were broken when the Geiyo earthquake occurred in March 2001. It is relatively new rod as it is about 13 years old. The assumed position of the breakage is the minimum cross sectional area in the center of the rod as shown in Fig. 3, which is a different position of the broken rods this time.

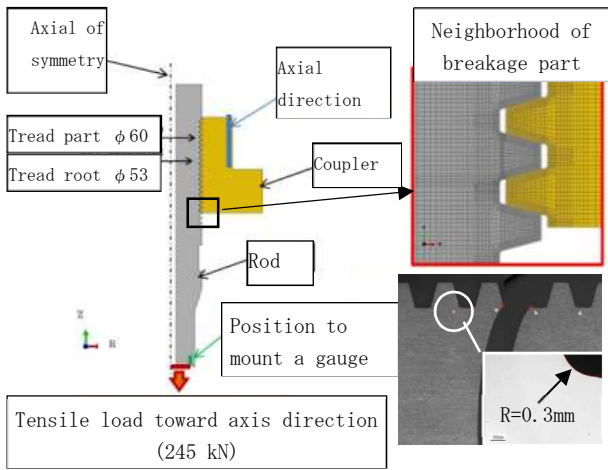
Fig.7 FEM analysis model diagram

Fig.7 shows a model diagram. The rod and coupler were modelled by using two-dimensionally axisymmetric models to conduct the FEM analysis using ABAQUS, a general-purpose analysis code.

When making the model, the number of remaining screw threads of the coupler was set to three in order to similar the actual structure to reproduce the condition of damaged rod. The thread root R, where crack occurred, was set to 0.3 mm that was measured from a macro photograph of the cross section of the broken rod.

Fig.8 shows the maximum principal stress contour when tensile load to the axis direction was applied. The stress concentration was identified from the thread root R located in the first row from the engaged part that is assumed as the starting point of the fatigue crack.

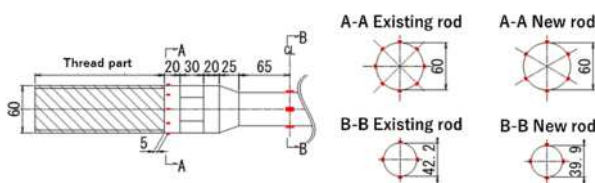
Fig.11 Positions to mount a strain gauge

Fig.10 shows a loading frame. The loading frame is constructed so that loads can be transmitted to the test piece installed on a diagonal member by applying loads to vertical material. Fig.11 shows the positions to mount a strain gauge. In the small diameter part, single axis gauges with the length of 5 mm are installed at intervals of 90° for measuring nominal stress. In the neighborhood of thread part, single axis gauges with the length of 1 mm are installed at intervals of either 45° or 60° for detecting the occurrence of cracking.

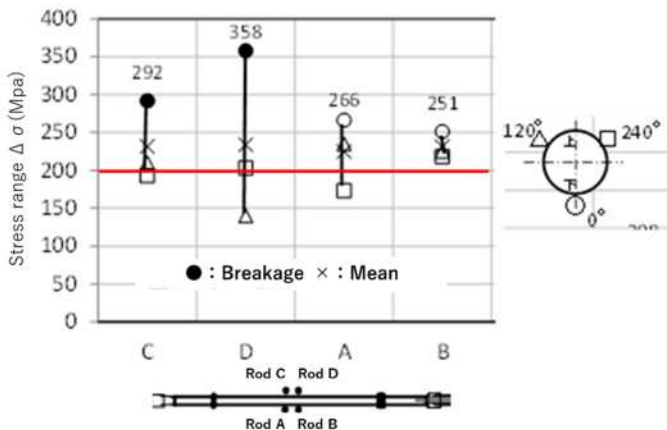
Fig.12 Stress range from 72-hour stress frequency measurement at a actual bridge

For setting the applying load, the load range $\Delta P = 130$ kN ($P = 20-150$ kN) is set according to the maximum stress range of the small diameter part obtained from the 72-hour stress frequency measurement at the actual bridge shown in Fig. 12 to allow the maximum stress range of 200 MPa to act at the small diameter part. A repetition frequency is set to 3 Hz.
